DOE/NASA/0017/1

CERAMIC APPLICATIONS IN TURBINE ENGINES

Progress Report for 1 July 1979 to 31 December 1979

Detroit Diesel Allison Division

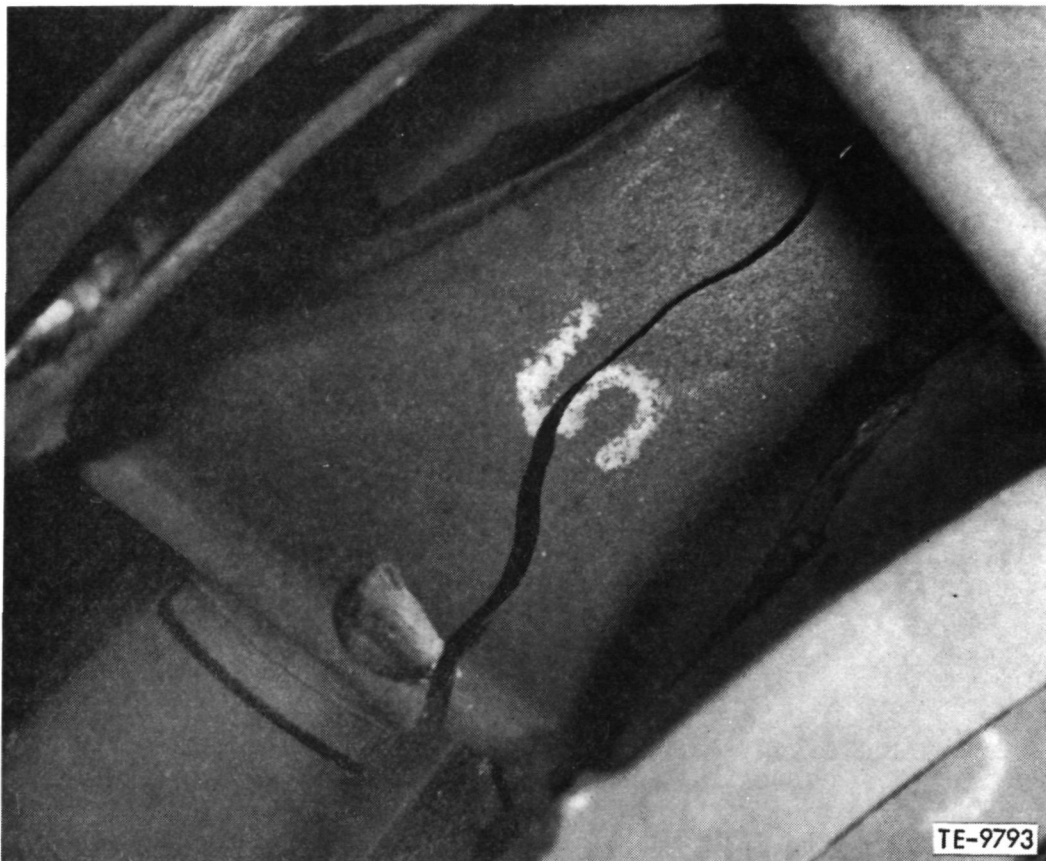
Test 2 consisted of 128 hours of truck cycle durability, which was interrupted after four hours of testing by a failed silicon carbide vane (Figure 5). The failed vane was a first generation silicon carbide vane which had accumulated 1211 hours of engine testing. Engineering and Materials Research failure analyses have not conclusively determined the reason for failure. No evidence

Figure 5. Failed silicon carbide vane.

of flaws or other material defects was found and no indication of load input from surrounding metal parts was evident on the failed vane. However, signs indicate that the plenum (which directs the burner outlet gas into the gasifier nozzle assembly) may have shifted position into the vane row at the location of the failed vane. The broken vane was replaced, the plenum shifting problem was resolved, and testing was continued without additional incidents.

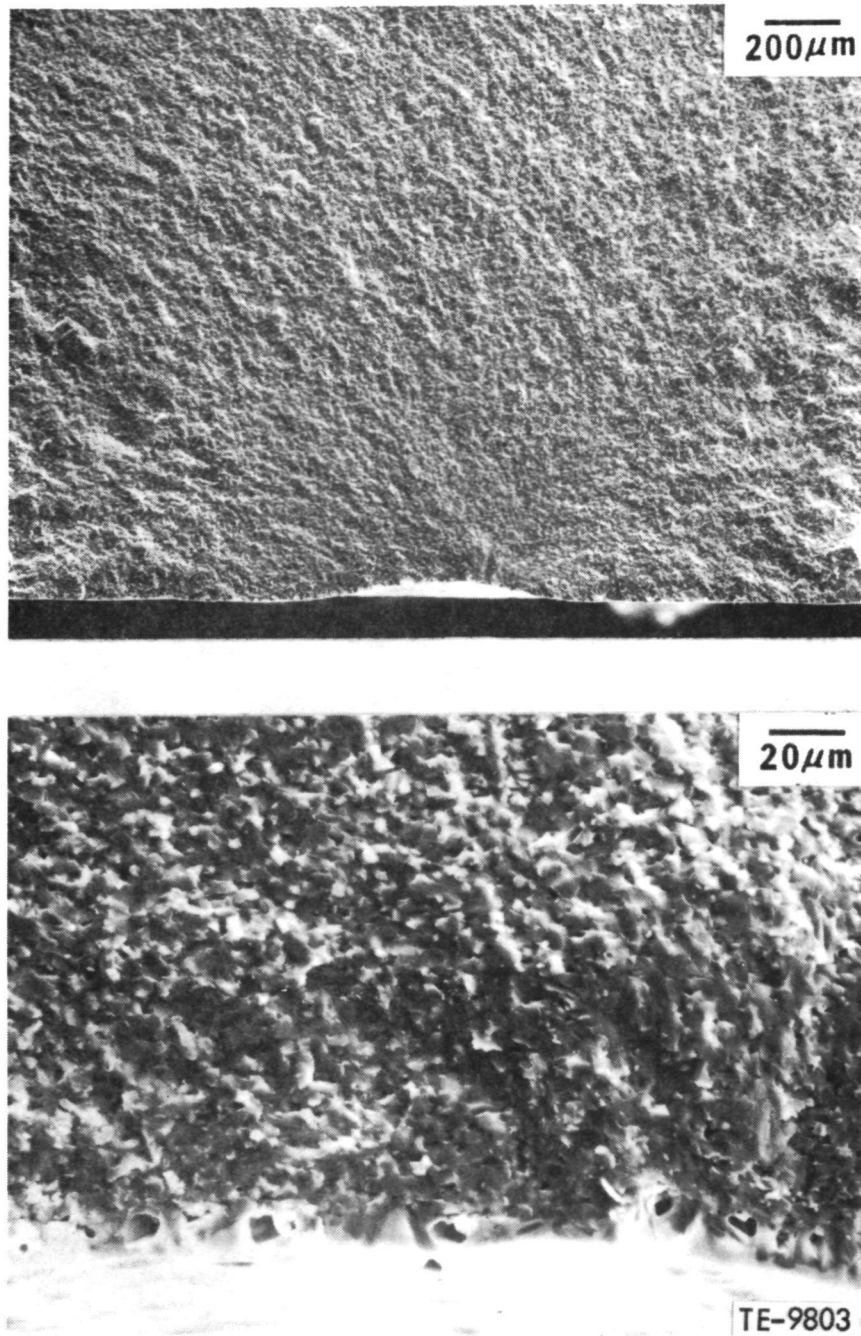
Figure 14. Fracture surface of slip-cast, oxidized Pure Carbon RB SiC showing glassy puddle at failure origin.

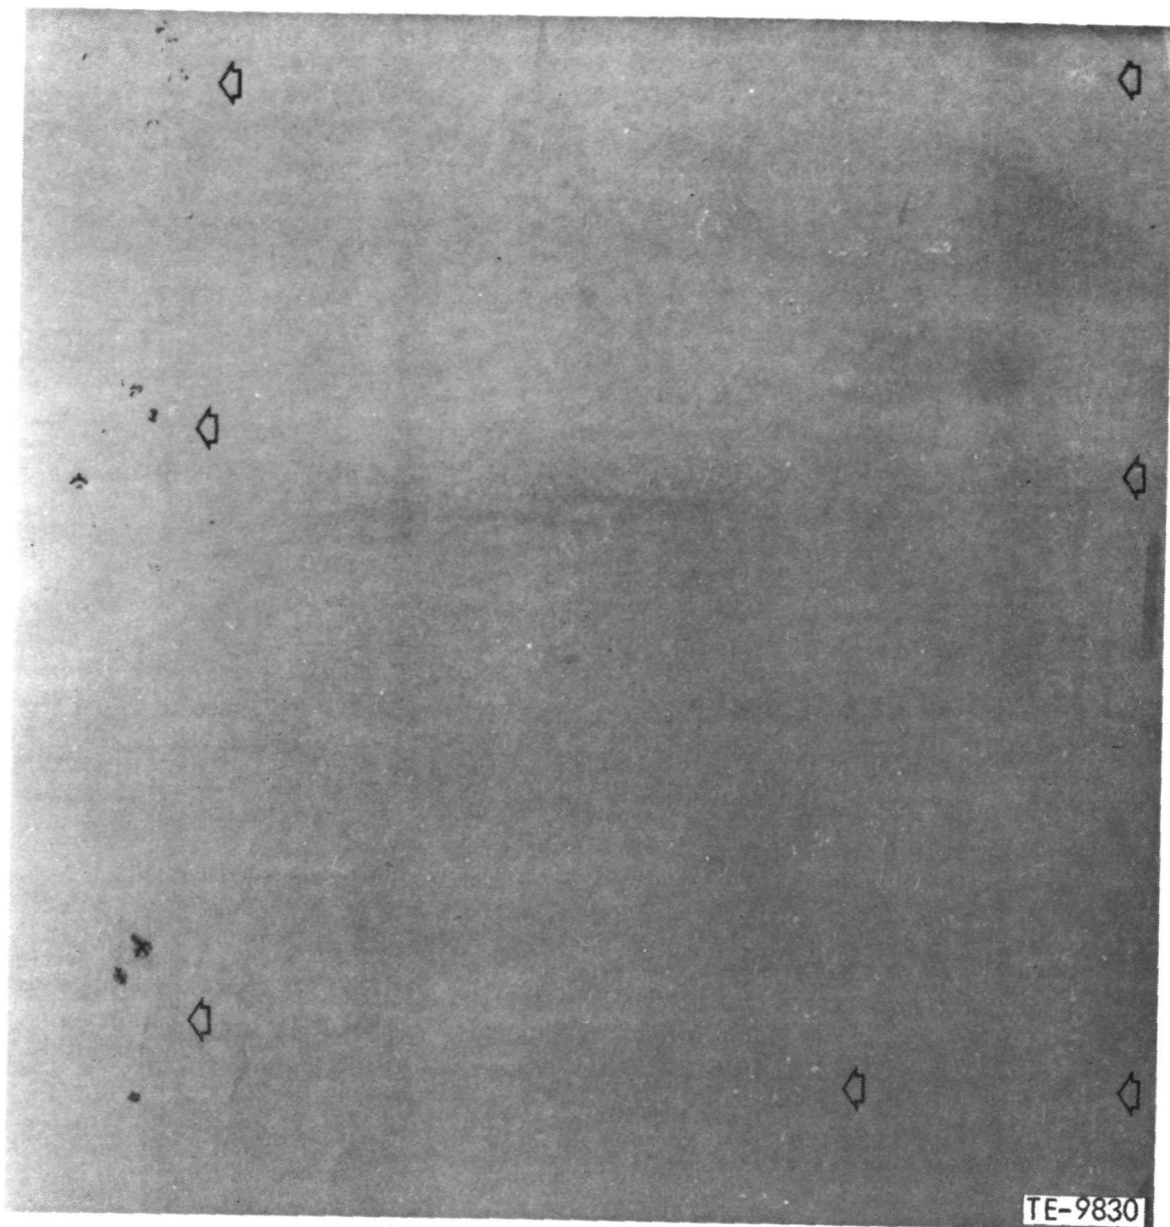
Both billets were radiographed, using a Norelco X-ray system that had a glass window and a focal spot diameter of 2.5 mm (0.1 in.). The best results were obtained at 60 kv and 8 mA, using M-type Kodak film. Figures 45 and 46 show the positive of the radiographs of machined and unmachined billet, respectively. The dark areas represent high-density inclusions; the light areas are low density inclusions. Table XIII shows that the X-ray film density was quite uniform for the machined billet (#1301). Both the iron (Fe) and boron nitride

Figure 45. X-ray radiograph of machined, seeded billet (S/N 1301) of NC-132.

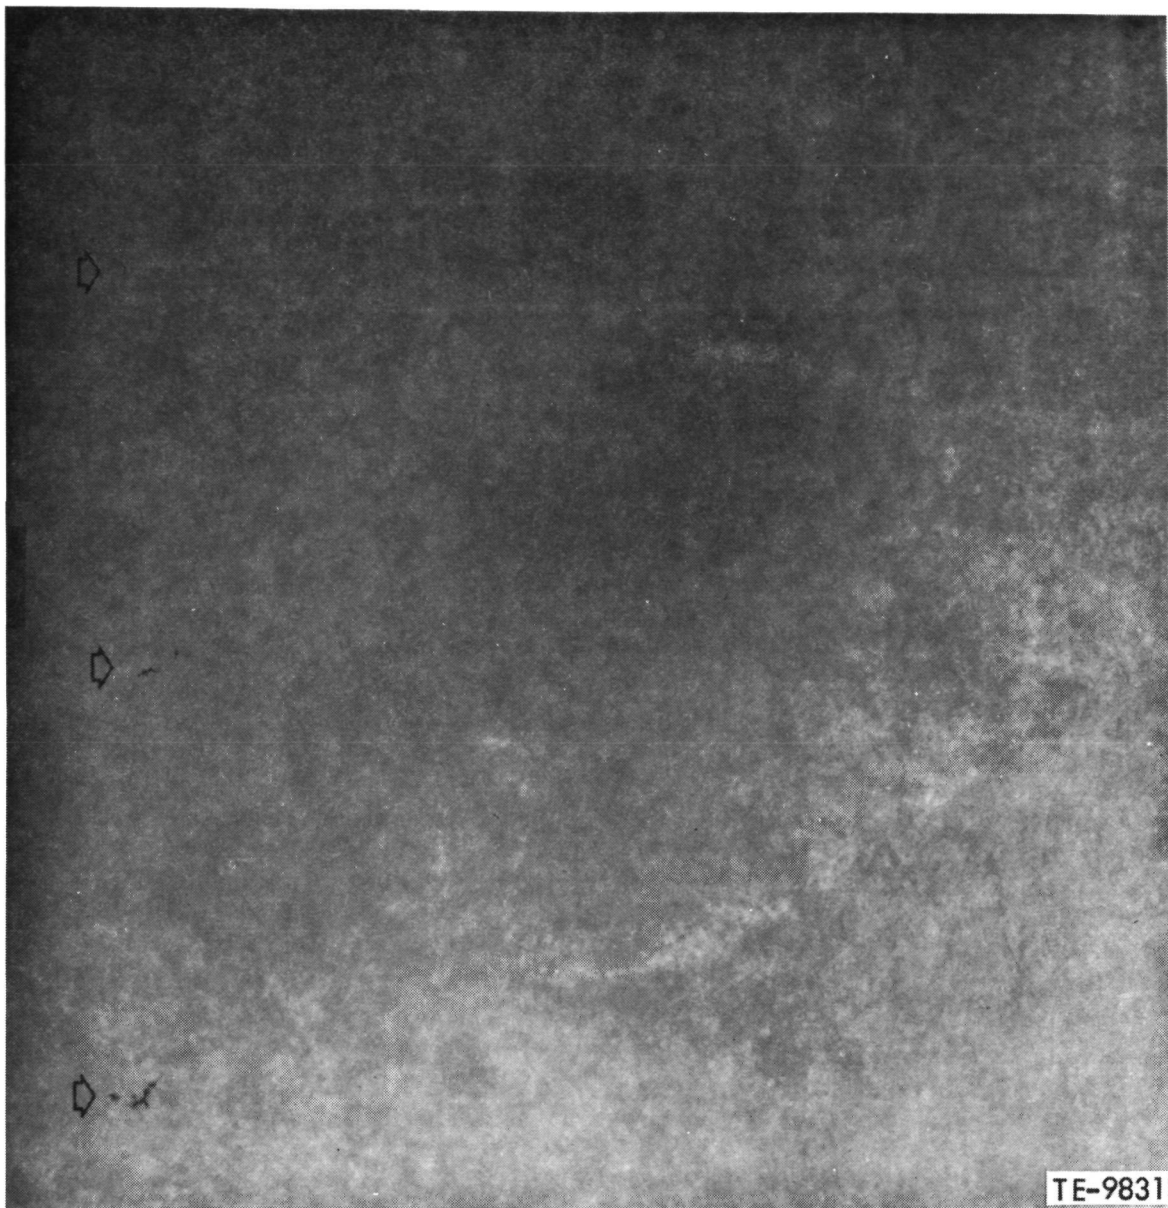
(BN) flaws were detected in all the three sizes. Silicon and graphite seeds were detected only in the 500 μm (0.020 in.) size. The sensitivity of the radiographic technique was 2.22% for Fe and BN and 8.9% for Si and graphite (C). Signal-to-noise (contrast) ratio was the greatest for iron and lowest for silicon. Figure 46 shows that the surface roughness of the as-fired billet (#1302) was excessive and caused large thickness variations which resulted in a radiograph of randomly varying film density. Only iron seeds were detected. Other low-density seeds, which were detected in the machined billet, were masked by the variation in the X-ray absorption.

Figure 46. X-ray radiograph of unmachined, seeded billet (S/N 1302) of NC-132.

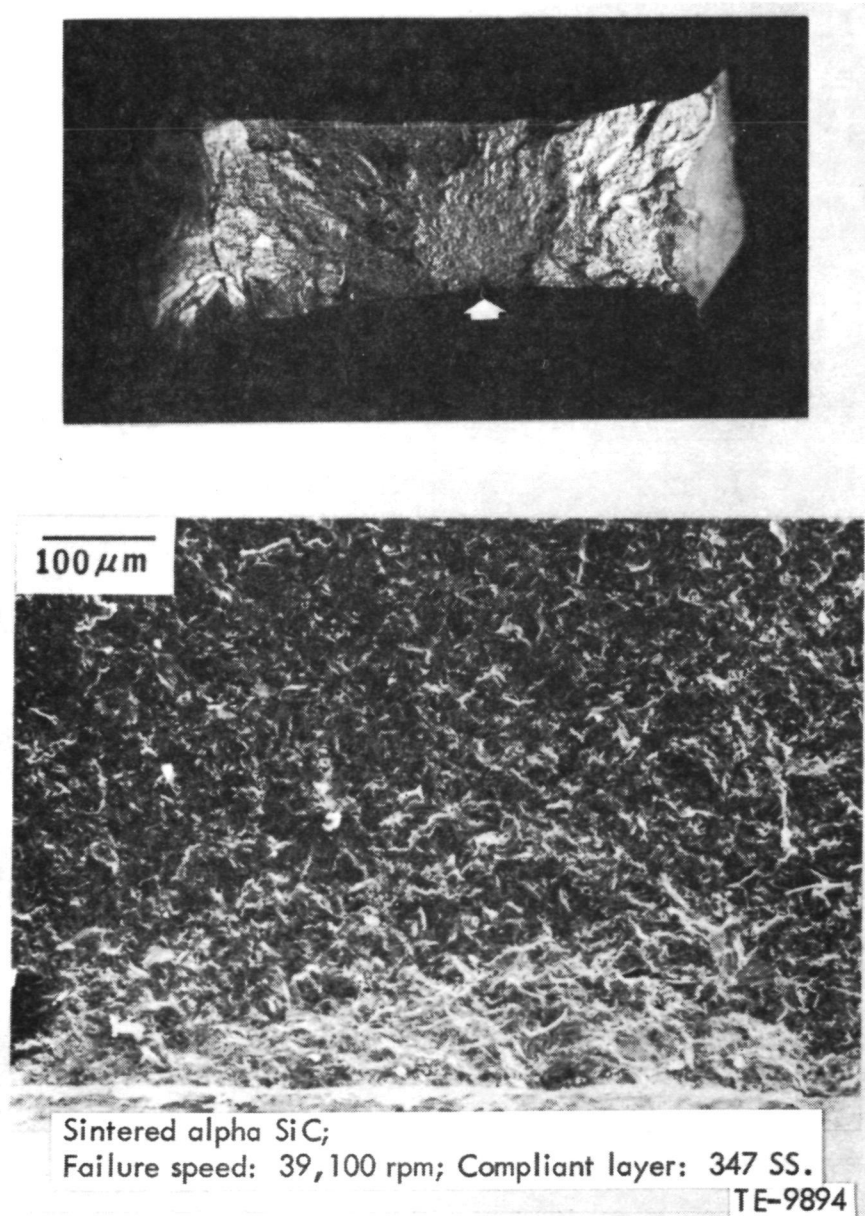
- o Coupon No. 22 failed at 39 100 rpm, using a 347 stainless steel compliant layer (Figure 80). The primary failure origin, indicated by arrow, is in a zone of high predicted stress (near the peak stress location), and no major flaw was found at this origin. Presumably, the fracture at the surface was a result of machining damage.

Figure 80. Spin coupon No. 22.

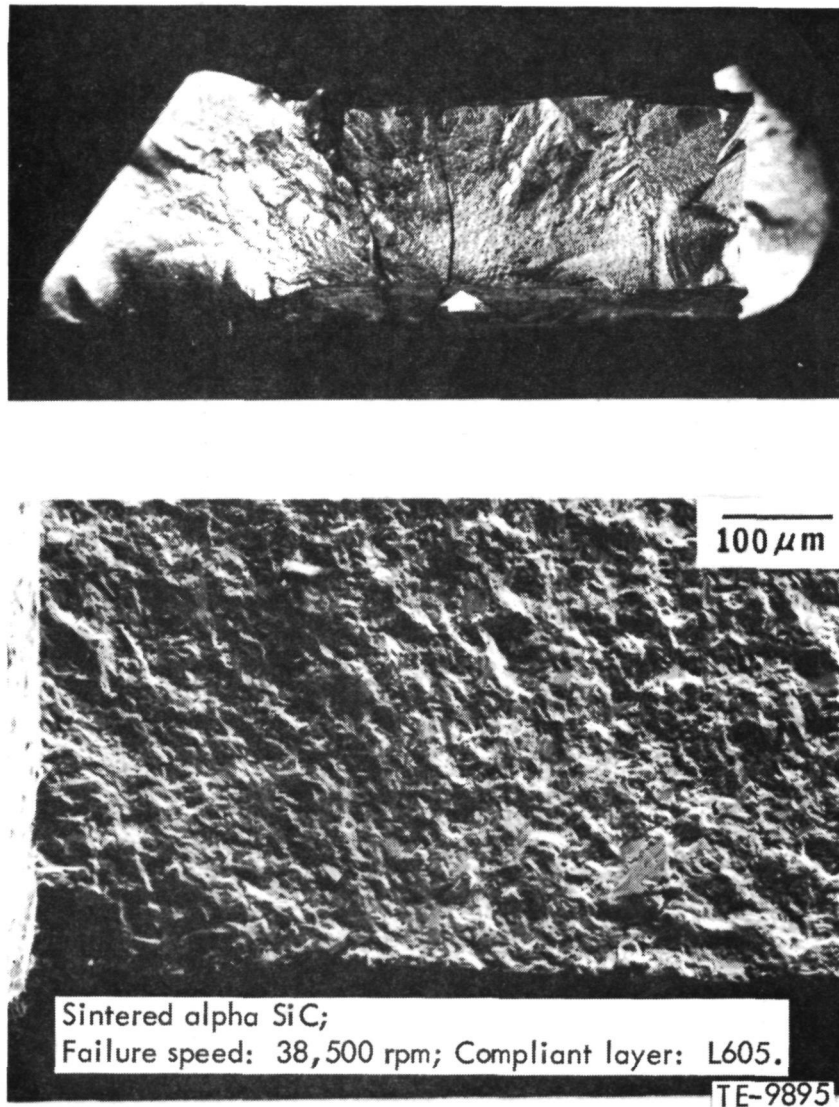
- o Coupon No. 23 failed at 38 500 rpm, using L605 material as the compliant layer (Figure 81). The primary failure originated at the surface in a zone of high stress near the peak stress location but, again, no flaw could be found.
- o Coupon No. 25 failed at 41 750 rpm, using an IN-600 material compliant layer (Figure 82). Primary failure originated at a rounded pore located at the predicted peak stress location. This pore is typical of those which control strength in material qualification test bars that were cut from billets along with the spin coupons.

Figure 81. Spin coupon No. 23.

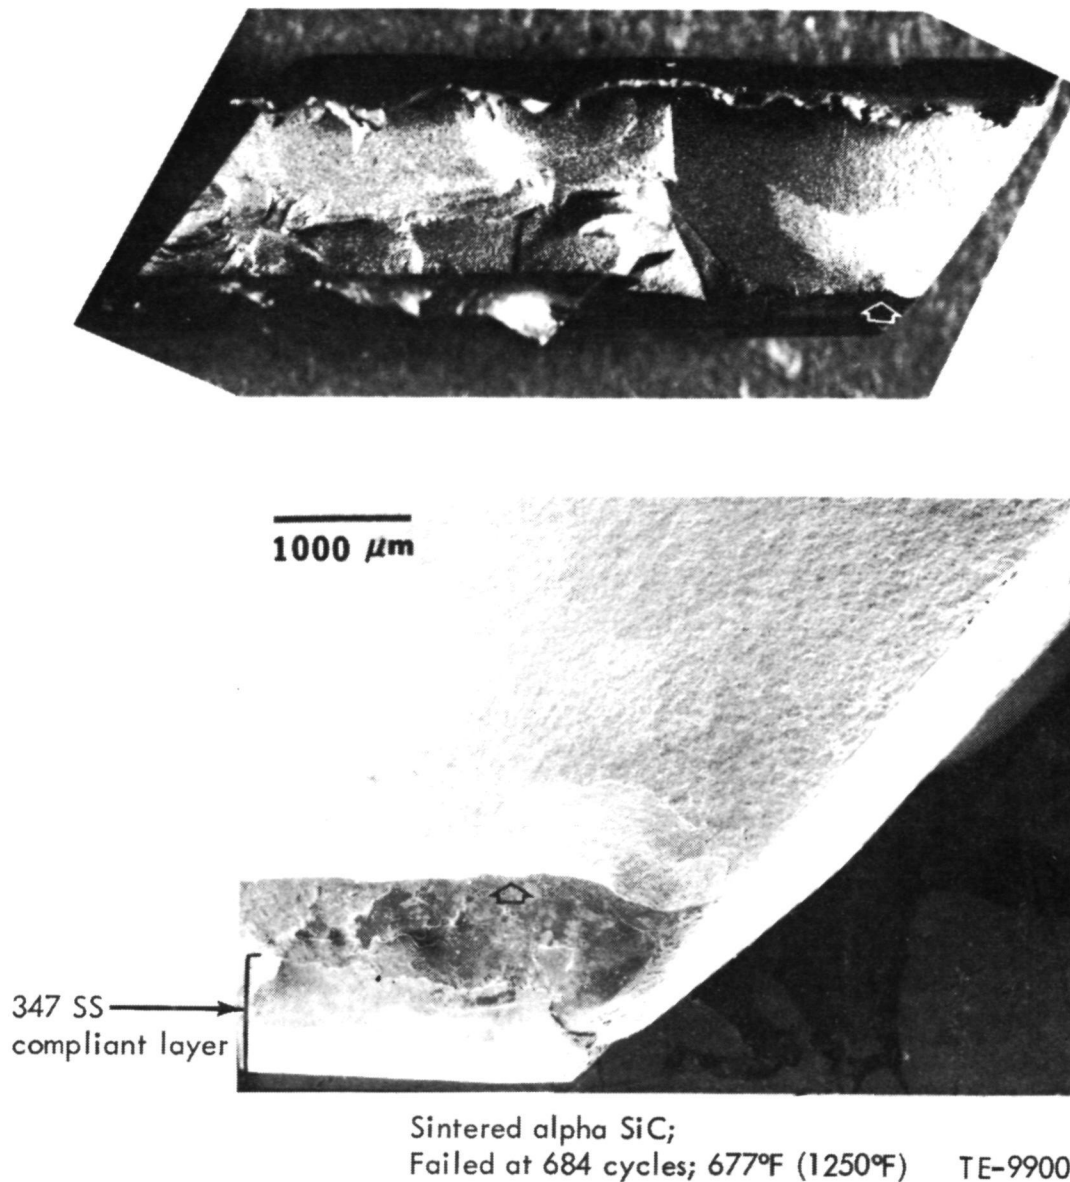
Closer examination of the failed spin coupon No. 20 reveals the relationship between compliant layer thin-out position and coupon fracture origin (Figure 86). Failure originated at a point of local contact between test disk and ceramic coupon. Multiple horizontal cracks, shown in Figure 87, are located at the failure origin and are typical of high Hertzian stress failures in brittle materials.

Figure 86. Spin coupon No. 20.

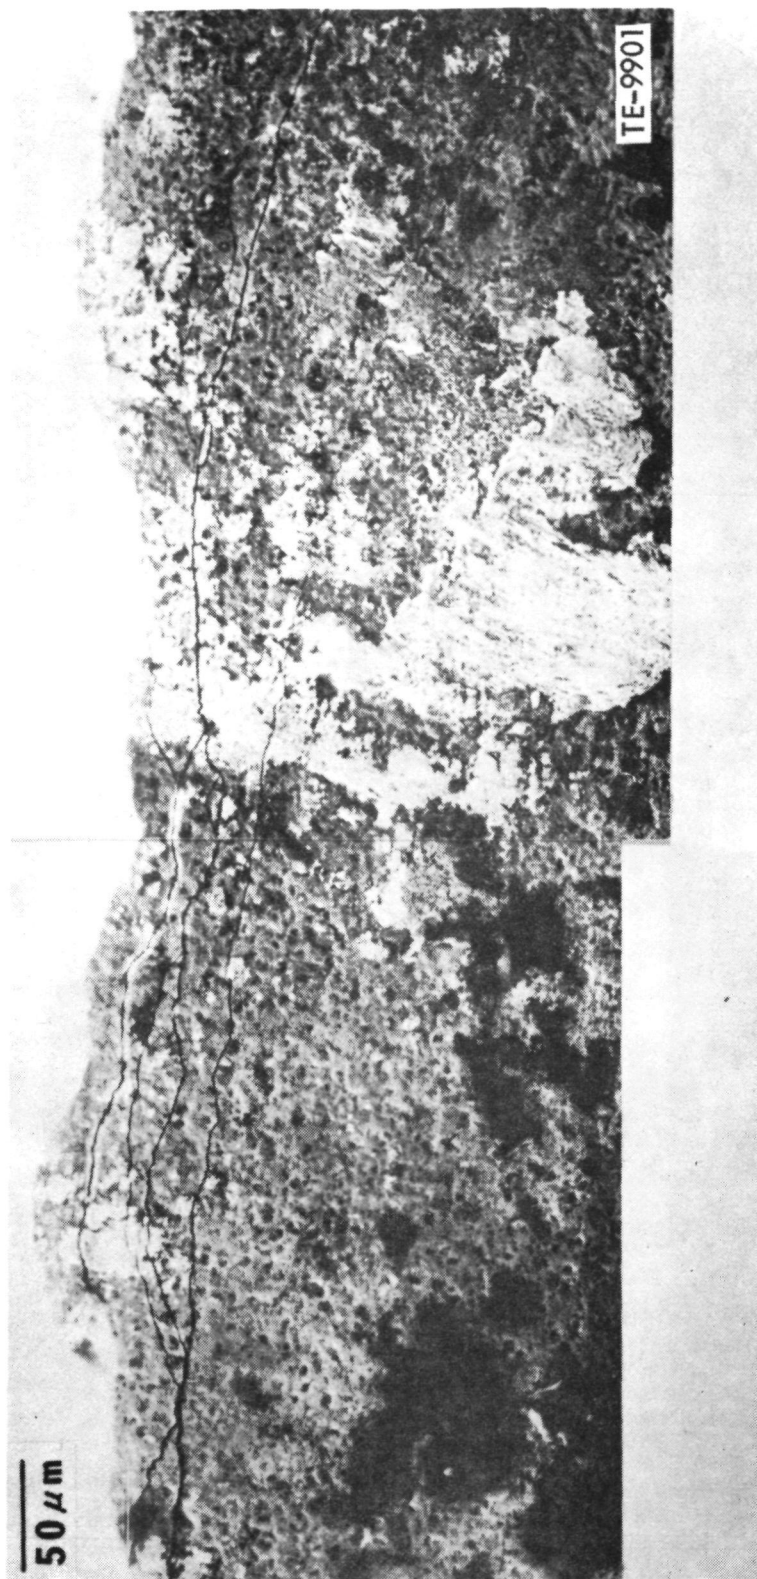
Figure 87. Multicrack at peak stress area in spin coupon No. 20.

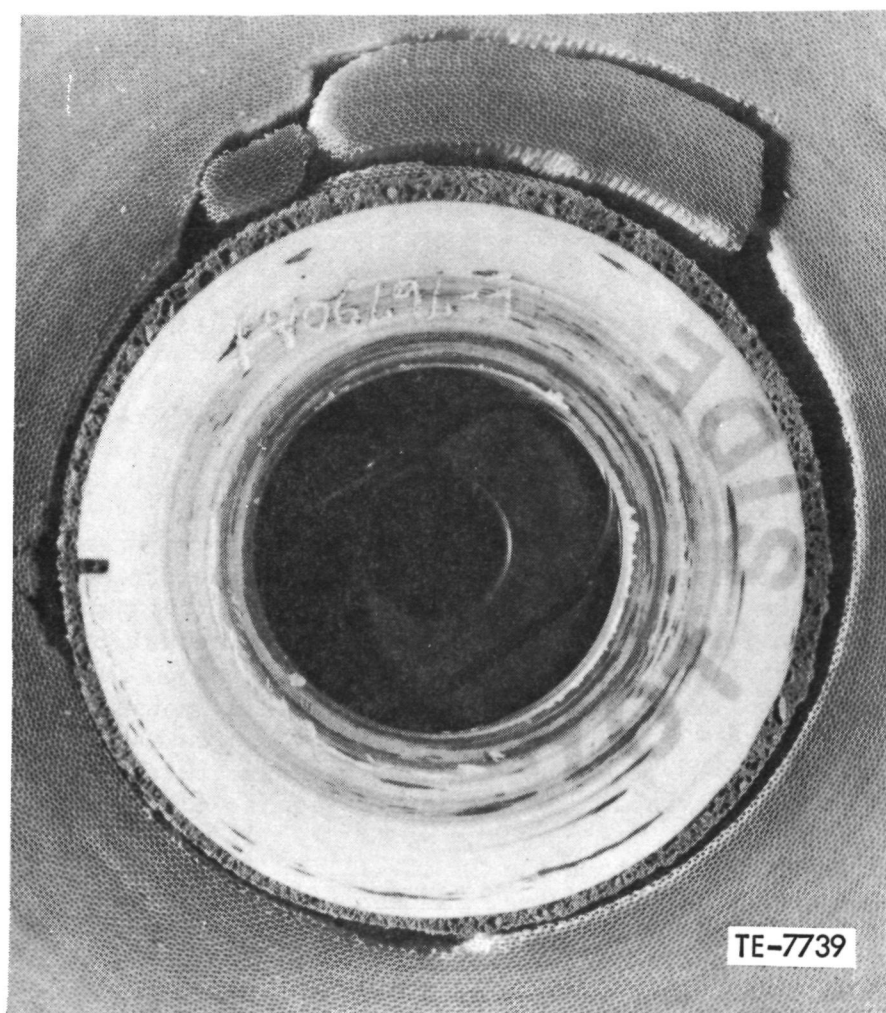
The two disks which were completely broken in the regenerator rig had each run about 5 hours at lower speeds and failed after about 45 minutes at 100% engine speed conditions. The 100% speed represents the maximum pressure and torque but not the maximum temperature encountered by a disk. At the radii where these failures occurred, stress analysis shows that pressure loads are by far the dominant stress producer. Consequently, a 30% overpressure proof test has been incorporated into the hot rig test of each set of seals and disks.

Figure 91. Regenerator disk hub failure encountered during hot rig running.

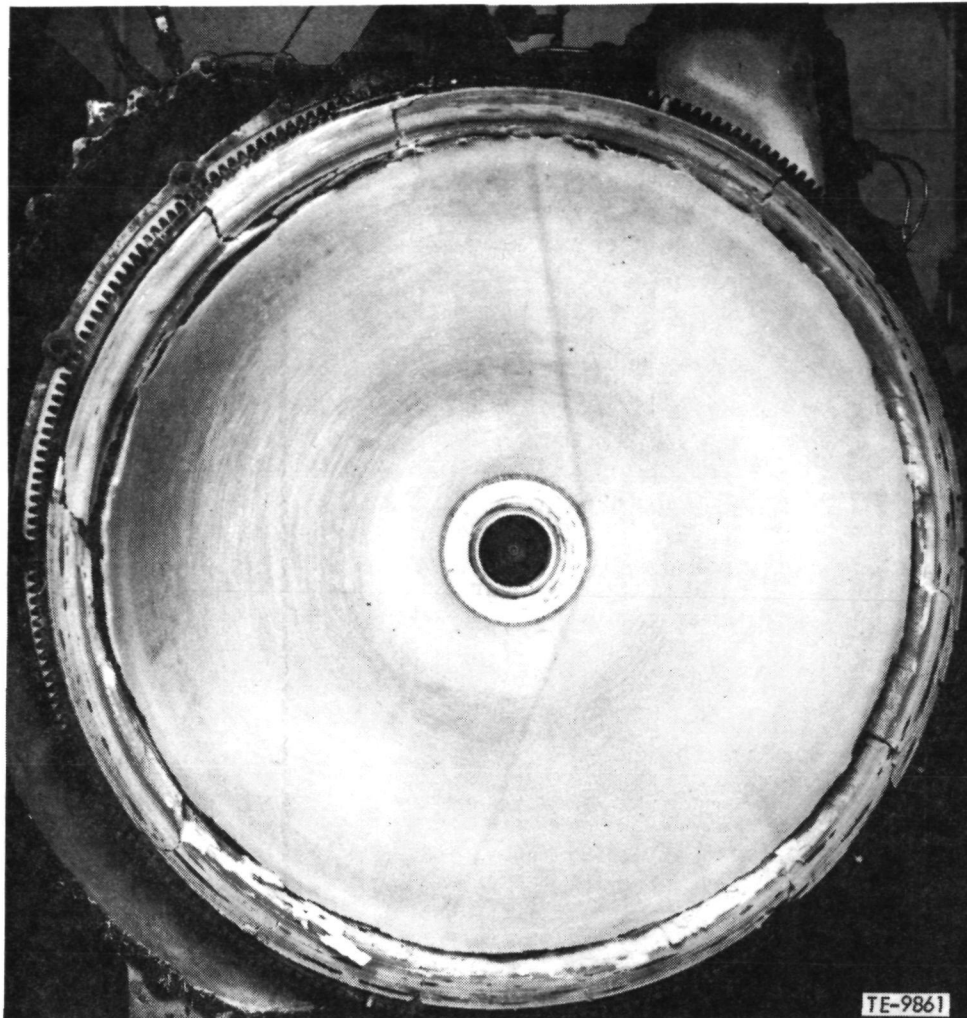
The second disk failed at about the 28-cm (11 in.) radius, as shown in Figure 93. This disk also had the abnormal "S" shaped passages and consequent separator distortion; however, it was milder near the failure area than elsewhere and not judged to be responsible for the failure. Correlation of matrix strength and wall thickness demonstrated that this failure was the result of thin separators. Regression coefficients show a very strong dependency of

Figure 93. Failed ceramic regenerator disk (DOE transit coach project).

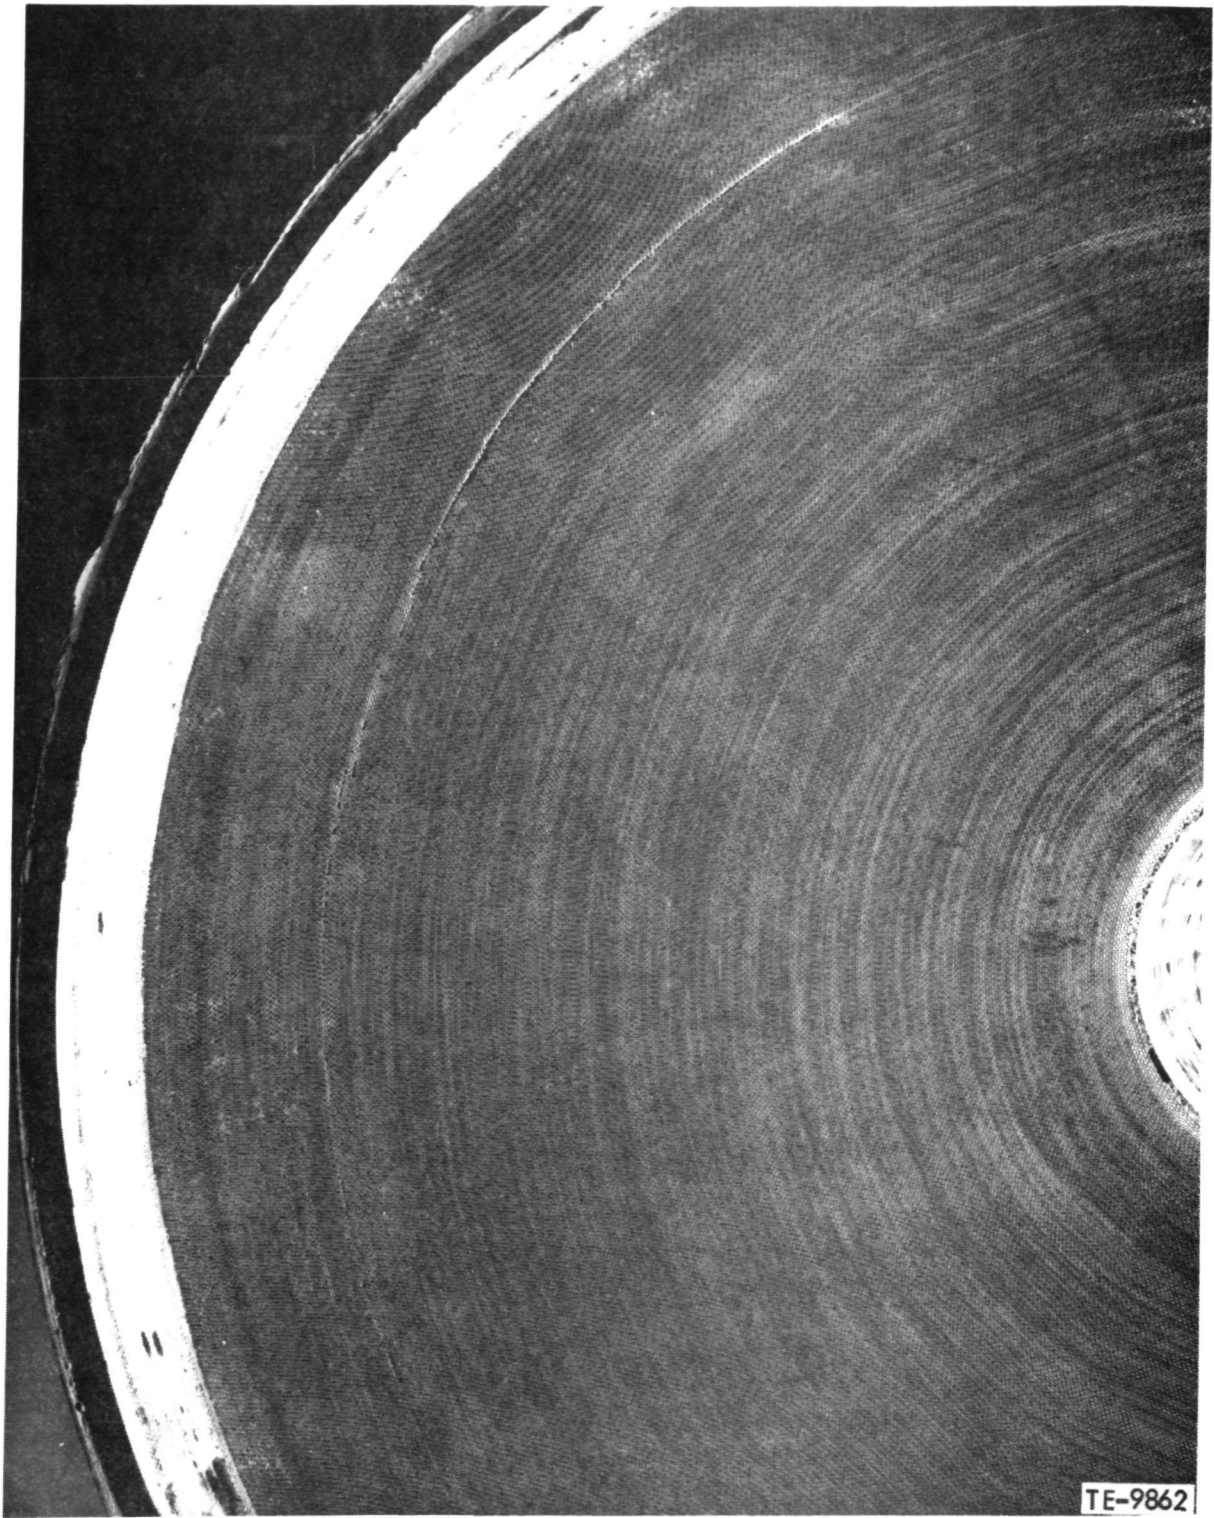
Figure 94. Cracked ceramic regenerator disk (DOE transit coach project).

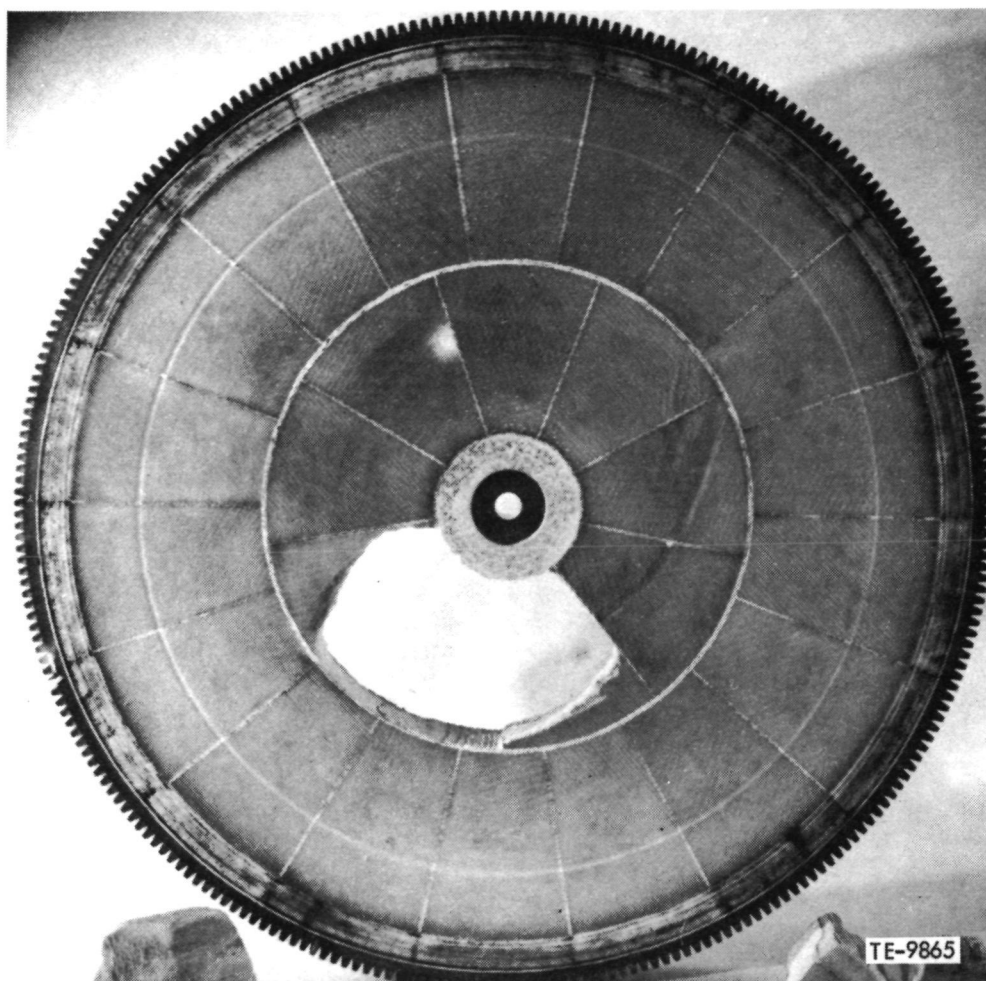
Figure 96. Failed NGK regenerator disk after 3.17 hours of rig testing.
